TURBO PERFORMANCE SDN BHD
Solution for New & Remanufactured Turbocharges

OTHERS DEPARTMENT

1) Air compressor items

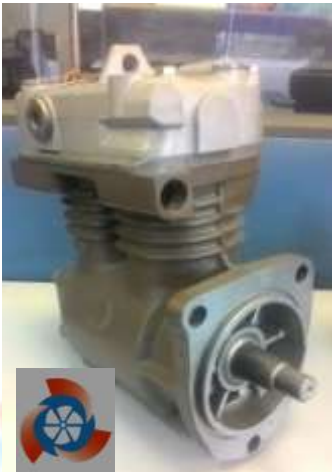
- Volvo FM12 V1, FM12 V2, FM400, FM10, FL10, FH12
- Scania S94, S113, S124 (Knorr & Wabco)

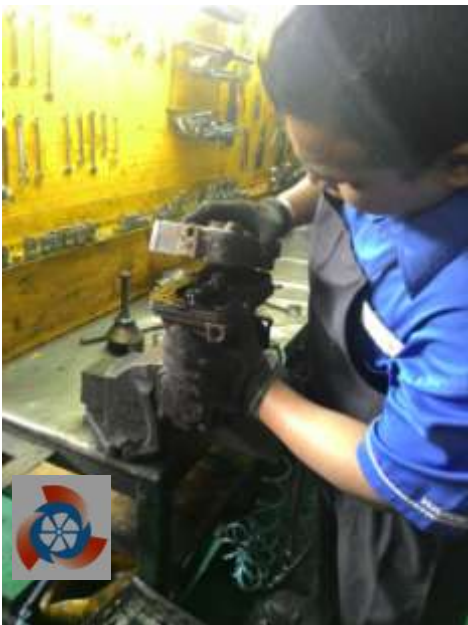
- 2) Every item brought in for remanufacture (sometimes referred as item reconditioning) undergoes an initial inspection and is graded before being carefully dismantled for cleaning and degreasing. Bearing, piston, piston ring and other small items are discarded as a matter of policy

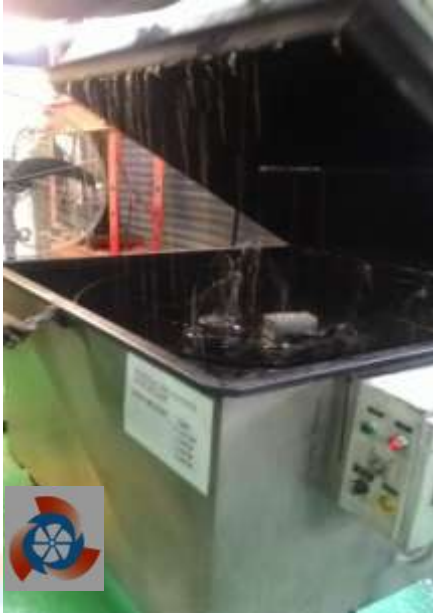
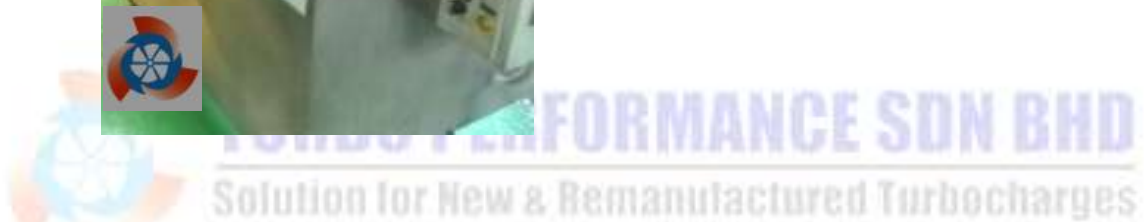
- Wash Machine – Head, Crankshaft, Piston and block air compressor are cleaned in a high temperature pressure wash tank and ultrasonic cleaner to fully ensure removal of carbon deposits

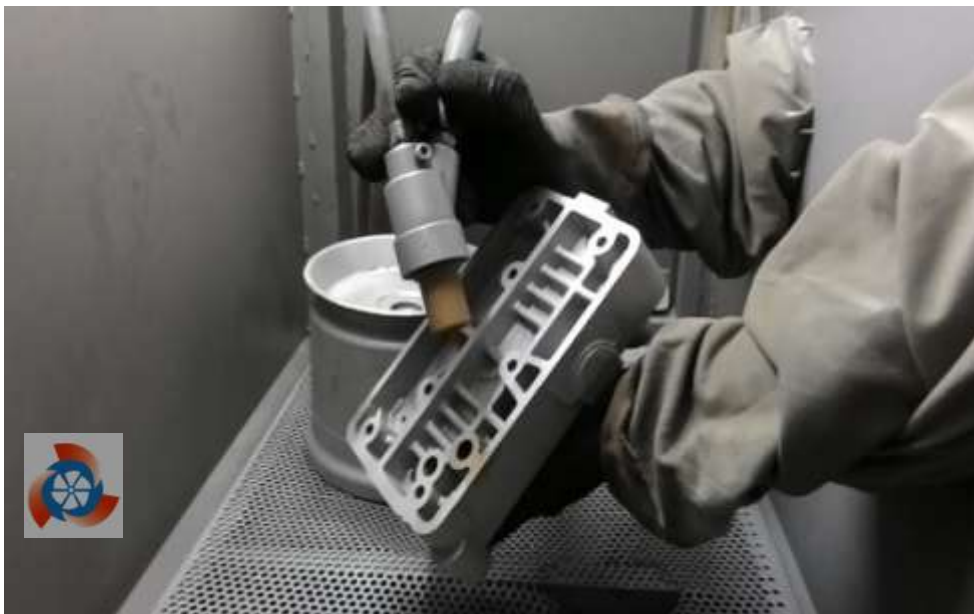
- Sand Blasting – All major components such as head, block and plat are checked against the manufacturer specifications. Components that do not meet the required tolerance / high standards are replaced as matter of course

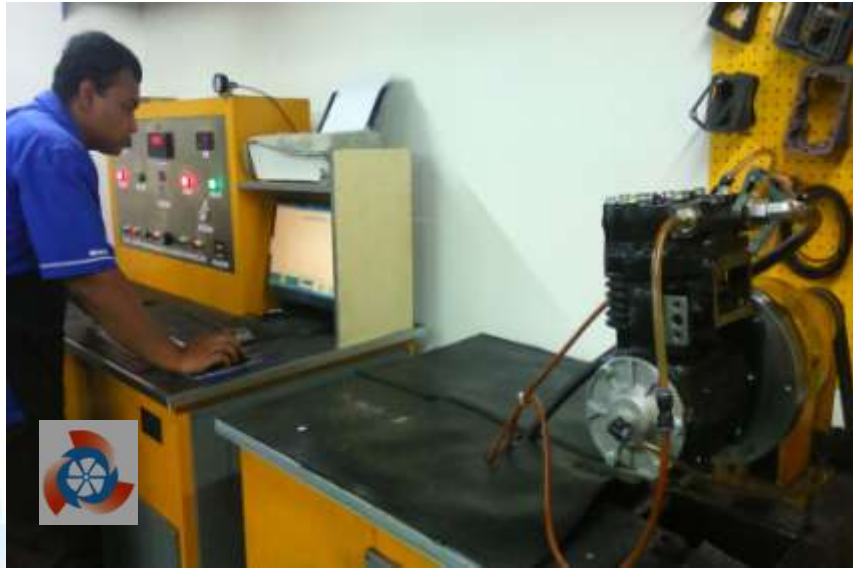
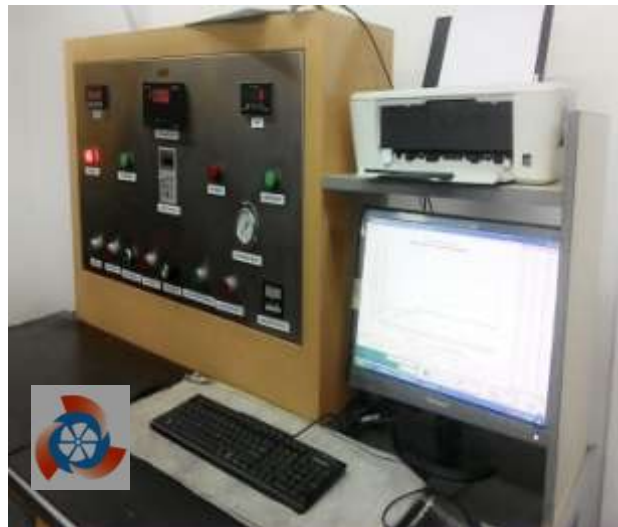
- Air compressor Test Bench
 - i. Pressure bar will up until 8 (TEST OK)
 - ii. If below than 8 pressure, compressor will slow (NOT PASS)

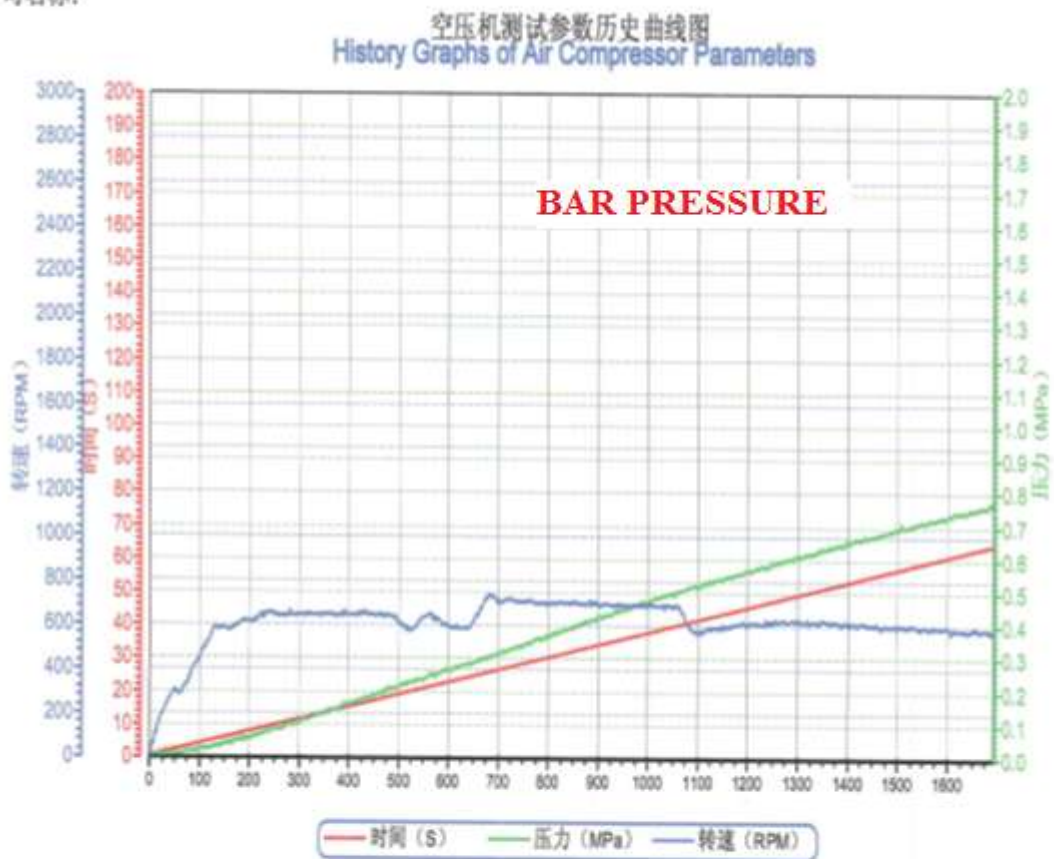
- Test result

顾客名称: 维修编号: 0-04083 产品编号: .01 2. 2015-08-07 10:48

车 款: WABCO FL10 技术人员编号: 207 日期: 2015-08-07 时间: 10:48:04
